# Characterization of Electron Beam Free-Form Fabricated 2219 Aluminum and 316 Stainless Steel

# NASA USRP – Internship Final Report

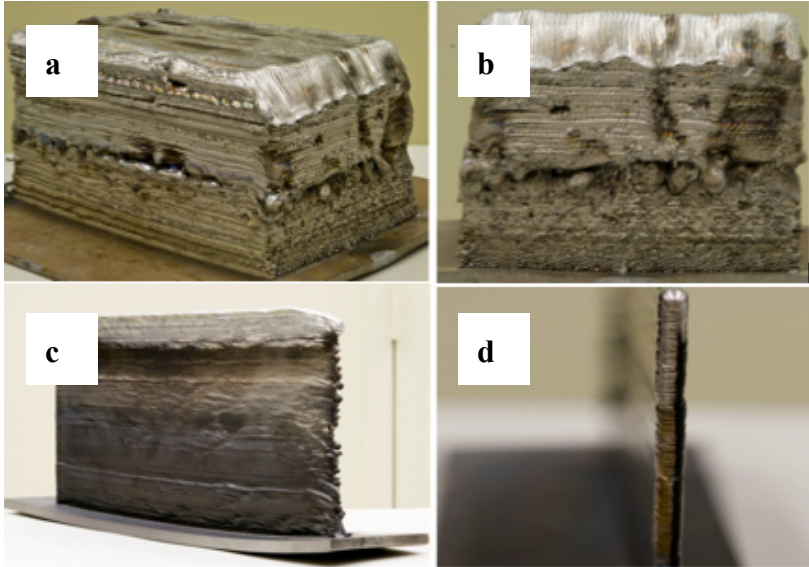
**Figure 1 EBF3 samples built at NASA Langley Research Center.** a) 10''x5''x5'' 2219 Al block b) 2219 Al multiple EBF3 bead passes – longitudinal view c) EBF3 316 stainless steel 9.8''x0.2''x4.8'' d) 316 single EBF3 bead pass – longitudinal view

In order to demonstrate the structural capabilities of the EBF3 built hardware, part geometries were manufactured, machined into coupons and tested for strength, fatigue and fracture toughness. The EBF3 materials tested were from commonly used aerospace alloys. 2219 aluminum was chosen due to its high fusion weldability and prevalent use on the International Space Station. 316 stainless steel was chosen for its high tensile strength and fracture toughness. The electron beam free form fabricated parts were evaluated based on anisotropic properties and the results were compared to minimum design values. Fracture toughness, fatigue crack growth, and tensile tests were conducted to assess the mechanical properties of the EBF3 manufactured part geometries. Metallography was further conducted to examine the effects of the layer additive welding process on material micro-structure as well as its strength and toughness properties.

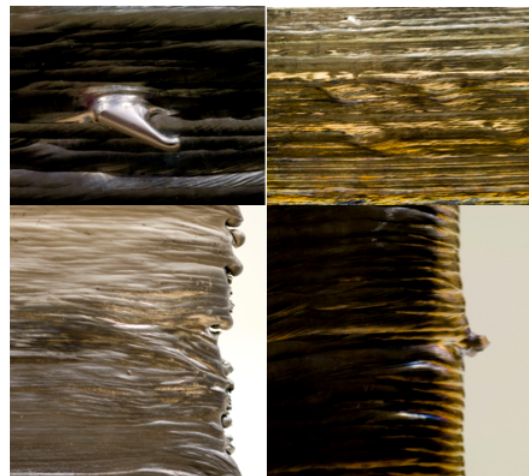
**Figure 2 EBF3 316 stainless steel surface anomalies**

Prior to utilizing costly screening techniques, EBF3 part geometries were visually inspected and evaluated based on finish quality, weld appearance, and layer height accuracy. Visual inspection results from the 2219 aluminum block and 316 stainless steel thin wall in the as deposited condition revealed numerous surface anomalies and voids (Figure 1a and Figure 2). Upon visually inspecting the EBF3 aluminum and stainless steel parts, tensile and fatigue crack growth testing specimens were machined at different orientations. A series of radiography tests were then employed on 55 tensile coupons and 18 fatigue crack growth specimens to examine the material quality. The radiography results of the EBF3 stainless steel specimens sectioned perpendicular and parallel to the direction of deposition revealed no cracks, voids, porosity, or lack of fusion lines. Figure 4 demonstrates a decently welded electron beam free form fabricated 316 stainless steel tensile specimen that was sectioned parallel to the direction of metal deposition.

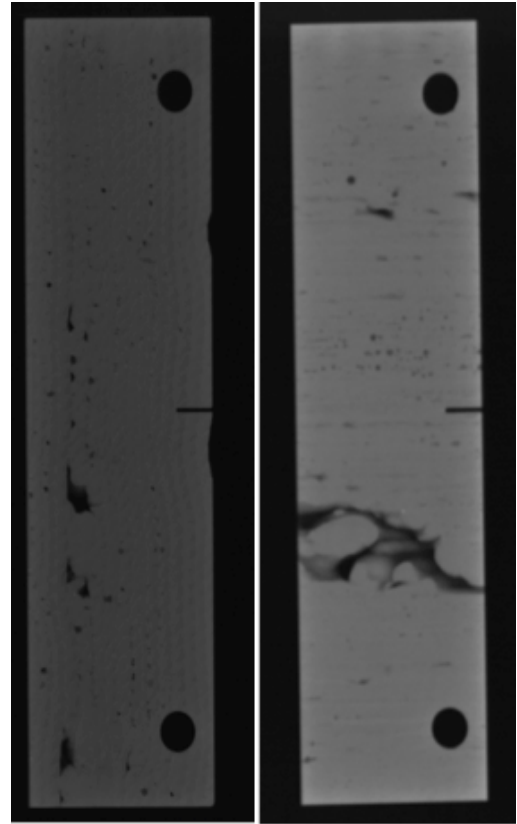
**Figure 3 Radiographs of ESE(T) EBF3 2219 aluminum fatigue crack growth specimen.** *Left – T-S orientation contained many voids, Right T-L orientation displayed lack of fusion lines*

Radiography results of 2219 aluminum specimens sectioned perpendicular to the direction of deposition demonstrated several discontinuities. The deposition parameters of the electron beam and the ability of aluminum to shrink by 12.5% upon solidification<sup>2</sup> were considered possible contributors to such defects. The radiography results of a few 2219 aluminum samples revealed several white spots that noted the presence of denser material than aluminum (Figure 4). An energy dispersive spectroscopy analysis on a few EBF3 2219 aluminum specimens, indicated high concentrations of copper parts disintegrated from the 2219 aluminum alloy which were delineated as white spots under the radiograph. This is expected in alloys with more than 5.5% copper and can also be seen in fusion welds.

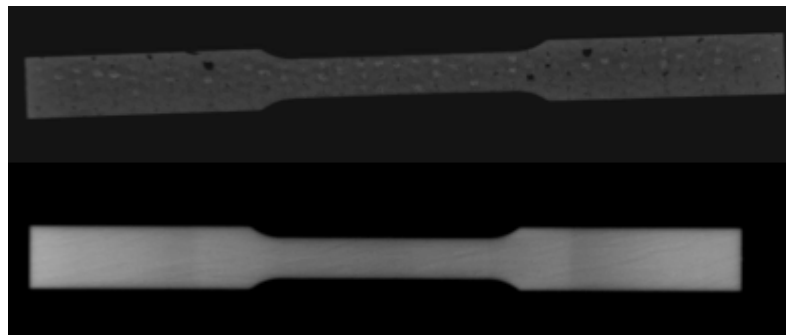
**Figure 4 EBF3 tension specimens.** *Top – 2219 aluminum with voids delineates disintegrated copper parts as white spots. Bottom – No discontinuities were observed in the 316 stainless steel specimen*

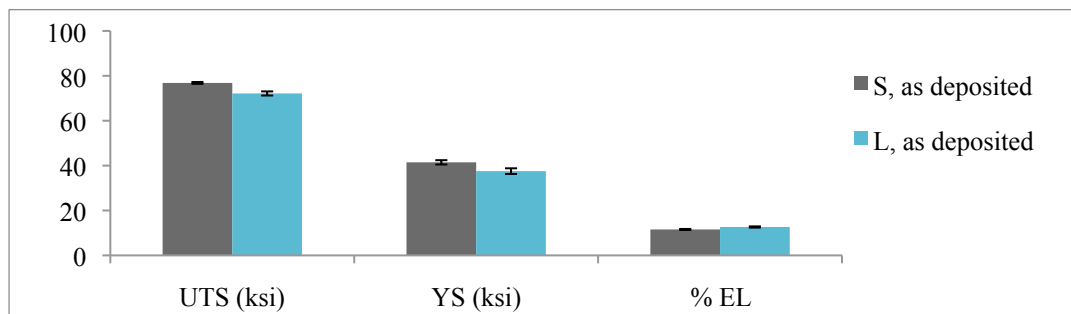
**Figure 5 EBF3 316 stainless steel anisotropic properties** *Short-transverse: across the layers. Longitudinal: along the direction of deposition*

Based on the ASTM Specification E8-09, Standard Test Methods for Tension Testing of Metallic Materials<sup>3</sup>, fractured tensile samples near the grip and neck are omitted. Ultimate tensile strength, yield strength and ductility results were obtained from 2219 EBF3 aluminum and 316 stainless steel samples (Figure 5). The anisotropic properties of the 316 stainless steel specimens in the as fabricated condition were evaluated. Specimens were pulled across the EBF3 layers (S) and along the direction of deposition (L). The results in the short-transverse direction ( $\sigma_{\text{mean}} = 76.8$  ksi,  $n = 5$ ) demonstrated a 6.5% increase in tensile strength compared to specimens pulled in the longitudinal direction ( $\sigma_{\text{mean}} = 72.1$  ksi,  $n = 4$ ). The results also indicate no significant differences in ductility values (Table 1). Error bars in the longitudinal direction for tensile strength yield strength, and ductility were 0.91ksi, 1.26ksi, and 0.26 respectively. The error bars in the short-transverse direction were 0.42ksi, 0.95ksi, and 0.23.

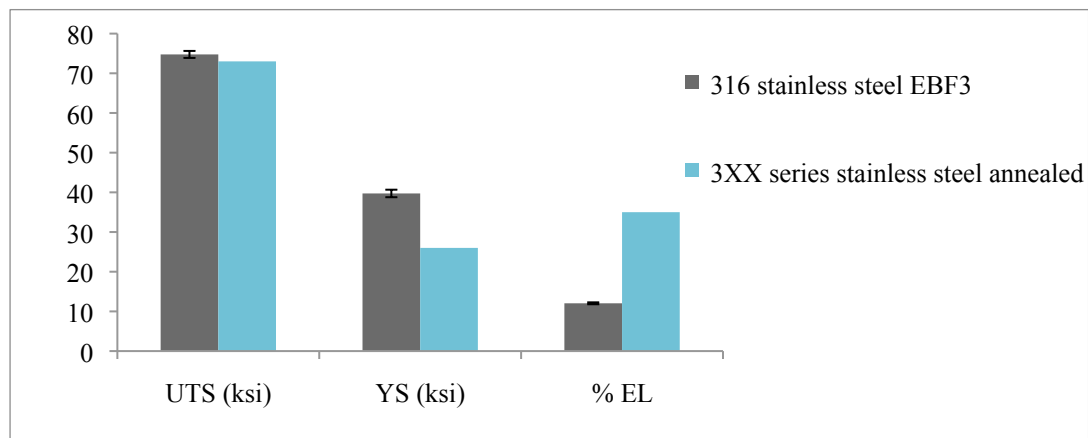
**Figure 6 EBF3 316 stainless steel tensile data and minimum design properties****Table 2 Comparison of EBF3 and conventionally manufactured stainless steel data**

Upon evaluating the anisotropic properties of the 316 stainless steel specimens in the as deposited condition, the mean tensile properties were obtained and compared to the properties of 300 series stainless steel in the annealed condition (Figure 6). The results demonstrated a marginal 2.3% increase in EBF3 tensile strength, and a 52.7% increase in yield properties ( $\sigma_{\text{yield}} = 39.7$  ksi,  $n = 9$ ) compared to the annealed condition ( $\sigma_{\text{yield}} = 26$  ksi). However, the 316 stainless steel specimens in the as fabricated condition demonstrated a 60% significant decrease in ductility. The differences between the two orientations reveal mildy anisotropic properties. The error bars for ultimate tensile strength yield strength, and ductility were 0.88ksi, 0.95ksi, and 0.24 respectively.

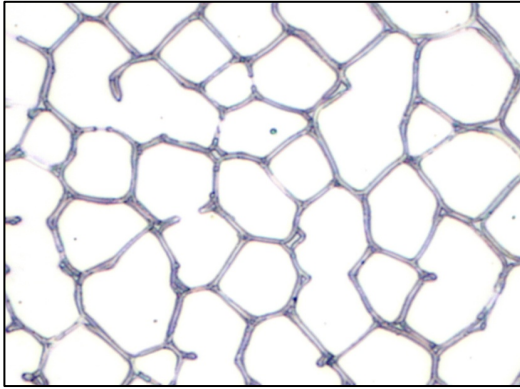
**Figure 8 EBF3 316 stainless steel microstructure (20x).** Etched with oxalic acid

Microstructural analysis of 316 stainless steel specimens in the as deposited condition indicated similarities to stainless steel microstructure in the annealed condition. Numerous metallographic images of 316 stainless steel specimens in the as deposited condition (Figure 8) displayed an array of hexagonal structures that was similar to stainless steel microstructure in the annealed condition (Figure 7). One noticeable difference between the two conditions was that stainless steel in the annealed condition had finer grain size compared to the as deposited condition. It was thought that the electron beam's low deposition rate during fabrication had contributed to this difference in grain size. Although, the two conditions displayed significant differences in grain size, the microstructures were very similar. These microstructural similarities have contributed to similar tensile properties between the EBF3 and the annealed conditions (Table 2). Further metallography analysis of 316 stainless steel specimens indicated that the layer additive deposition process did not disintegrate any metallic elements from the alloy.

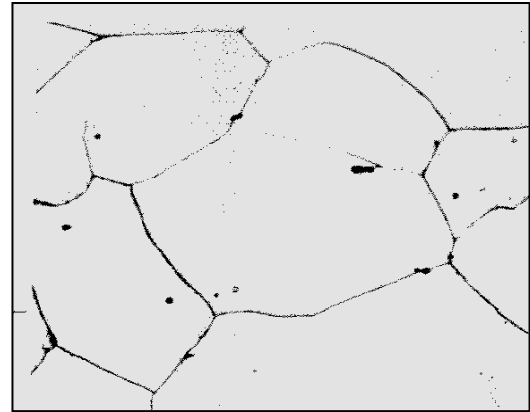
**Figure 7 Annealed 316 stainless steel (500x).<sup>4</sup>**

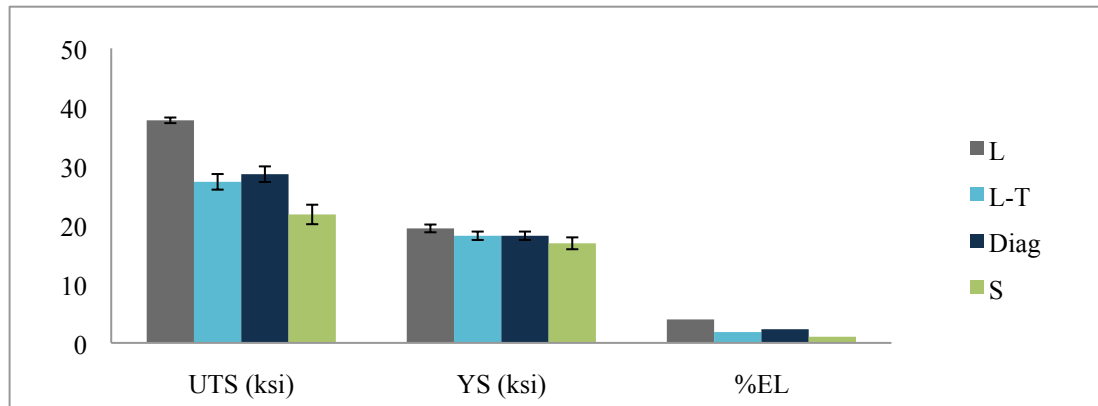
**Figure 9 Anisotropic tensile properties for 2219 aluminum**

After obtaining tensile results from the EBF3 316 stainless steel specimens, the tensile and microstructural properties of 2219 aluminum parts were evaluated. Visual inspection results of the 2219 aluminum tensile specimens revealed shear fracture and brittle surfaces, which was expected from 0.25" thick aluminum material. An ANOVA analysis of variance revealed significant differences between the 2219 aluminum anisotropic tensile properties in the as fabricated condition. Specimens pulled parallel to the direction of deposition (L) had significantly higher tensile strengths than specimens pulled perpendicular to the multiple bead passes (L-T), layers (S), and at 45° angles (Diag.). This was expected since tensile strengths are typically higher in the longitudinal direction than the long transverse directions. The tensile specimens machined perpendicular to the EBF3 layers ( $\sigma_{\text{mean}} = 21.8$ , ksi,  $n = 5$ ) had significantly lower tensile properties than longitudinal ( $\sigma_{\text{mean}} = 37.78$ , ksi,  $n = 10$ ), long –transverse ( $\sigma_{\text{mean}} = 27.34$ , ksi,  $n = 12$ ) and diagonal ( $\sigma_{\text{mean}} = 28.63$ , ksi,  $n = 12$ ) orientations at a level of significance  $p = 1.2E-07$ .

The inconsistent tensile strength values were due to differences in microstructural properties at those orientations. The EBF3 layer-additive deposition process had re-heated previously deposited 2219 aluminum material. This event had affected the grain size at subsequent layers and influenced the EBF3 2219 anisotropic

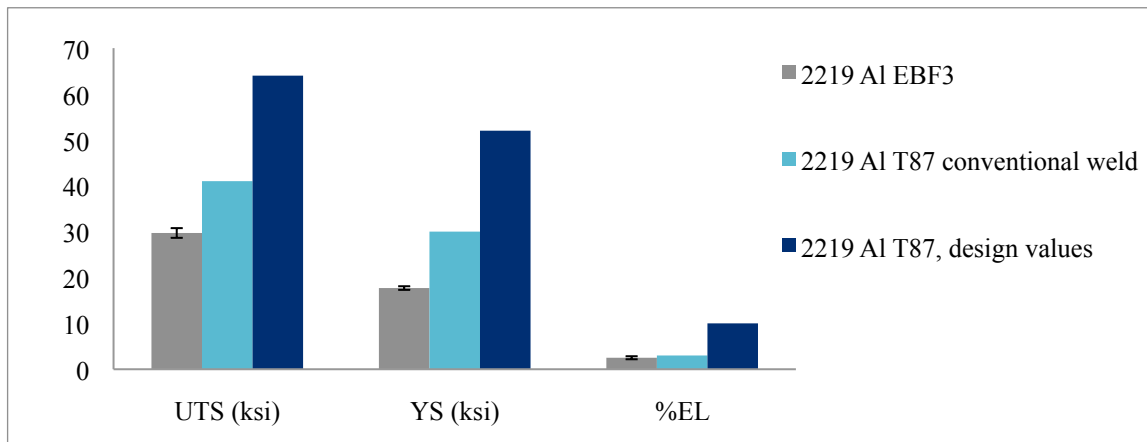
**Figure 10 Comparison of 2219 aluminum tensile properties in the as deposited and heat-treated conditions**

The mean tensile properties of the EBF3 2219 aluminum were then compared to conventionally welded and un-welded 2219 aluminum in the T87 condition. The results show that the 2219 aluminum in the as deposited condition had comparable ductility values to conventionally welded aluminum in the T87 condition (Table 4). The 2219 aluminum tensile and yield strength values in the as deposited condition had decreased by 27.5% and 41% respectively. The EBF3 tensile data also displayed a significant decrease in tensile properties when compared to minimum design values of 2219 aluminum in the T87 condition. The ultimate tensile strength, yield strength and ductility values had decreased by 52.8%, 64.6%, and 75% respectively. The EBF3 2219 aluminum error bars for the tensile strength, yield strength, and ductility were 1.06 ksi, 0.40 ksi, and 0.33 respectively. The tensile data for EBF3 2219 is significantly different since the material is in the as deposited, F-temper condition .

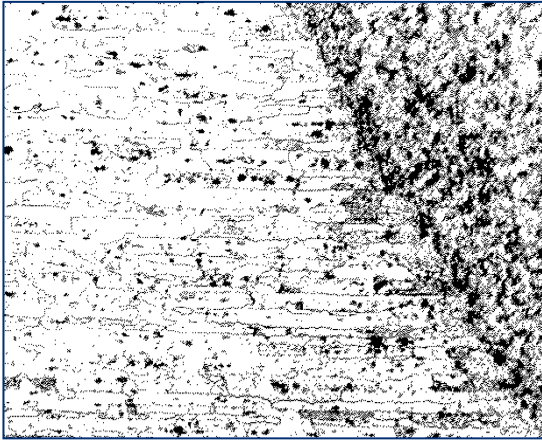
**Figure 11** Edge of fusion zone of a 2219 aluminum electron beam conventional weld.

Metallography images of 2219 aluminum in the as deposited condition had indicated comparable grain size and microstructure to conventionally welded 2219 aluminum (Figure 11). These similarities between microstructures have also contributed to similarities in material ductility (Table 4). Conversely, the EBF3 tensile properties were significantly lower than conventionally welded 2219 aluminum due to the EBF3 layer additive welding process that had reheated material and altered its grain size. A parameter that affected the microstructure of deposited material was the deposition rate of the electron beam gun. The low deposition rates had changed material solidification rates across the layers of the 2219 aluminum block. This occurrence had influenced the overall grain structure and decreased the tensile properties of the 2219 aluminum specimens in the as deposited condition.

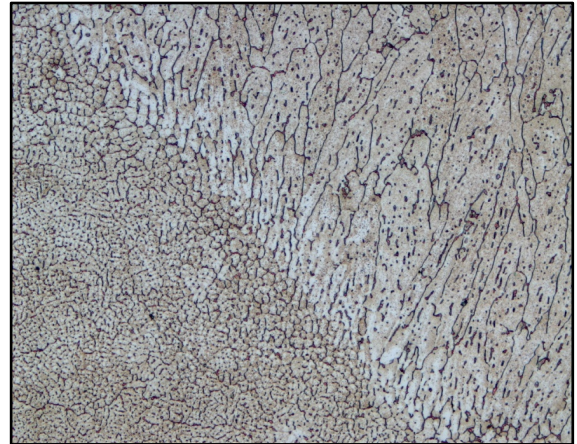
**Figure 12** EBF3 2219 aluminum weld. (Keller's reagent) *The different grain size is caused by the solidification rate*

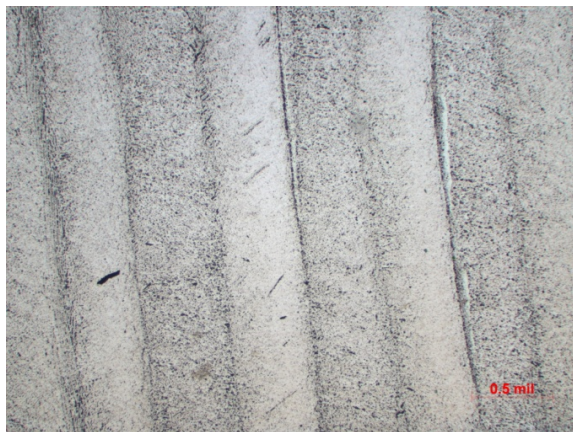
**Figure 13** EBF3 2219 aluminum 2219, as polished. *The metallograph displays bands of disintegrated copper between the bead passes*

The low deposition rates in addition contributed to the excessive diffusion of copper between the weld beads of the 2219 aluminum block (Figure 13). An Energy Dispersive Spectroscopy analysis further demonstrated high concentrations of disintegrated copper parts that were delineated as white spots in the SEM image (Figure 14). Ductility values were also influenced by the disintegration of copper parts from the 2219 aluminum alloy specimens. The tensile data and metallography results of the 2219 aluminum and 316 stainless steel parts indicate that future process parameters need to be adjusted to achieve high quality EBF3 parts for space flight.

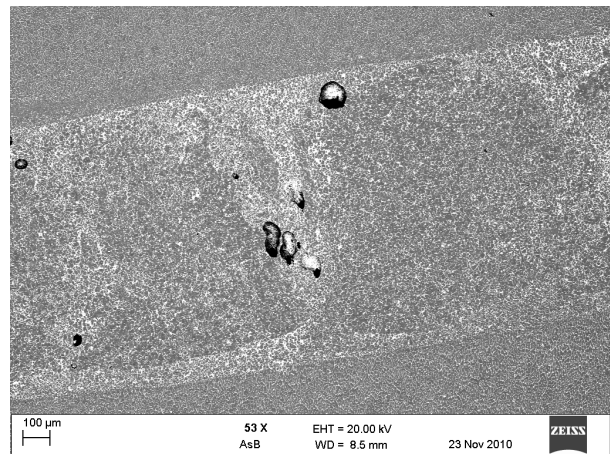
**Figure 14** SEM backscatter image of a magnified portion of a bead pass.

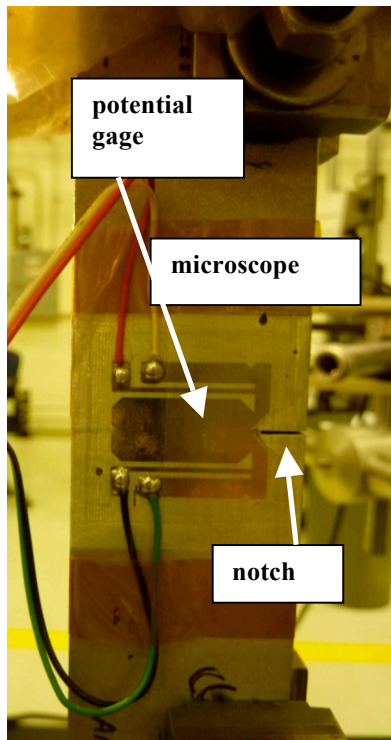
**Figure 15** A gaged ESE(T) 2219 EBF3 aluminum specimen. The specimens were loaded in tension-tension

Fatigue crack growth specimens were machined to eccentrically-loaded single edge crack tension specimen ESE(T), and chamfered to distribute nominal loads, and prevent bending and cracking at the specimen pin holes. The fatigue specimens were configured to ASTM E647-08 standard test method for measurement of fatigue crack growth rate<sup>6</sup>. Thin metal foil gages of 15mm in length were used as transducers to measure potential drop across the specimens and record crack length data. The fatigue crack growth specimens were configured for testing in the following process:

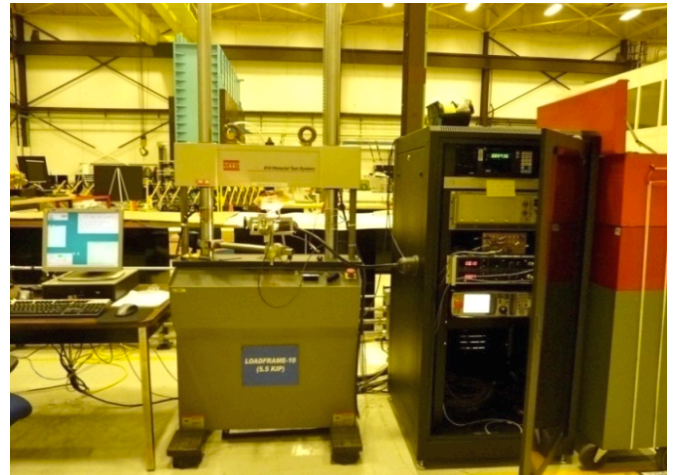
**Figure 16** Fatigue crack growth test set-up. Specimens were loaded in servo-hydraulic loading frame of 5.5 kip capacity.

- The specimen gage area was polished with 400 grit sand paper
- Specimens were then cleaned with isopropyl alcohol to remove the recast layer debris
- 15mm KRAK-GAGE®s were aligned with the specimen notch using a microscope
- Heat-activated epoxy was applied and the gage backing was removed to affix the specimens
- Specimens were then covered with Teflon sheet and placed in pressure jigs
- The jigs were positioned in an oven to cure the epoxy at 85°F for 90 minutes
- Wires were then soldered on the gage to obtain data acquisition values (Figure 16)

Fatigue crack growth specimens were installed in a computer controlled servo-hydraulic loading frame of 5.5 kip capacity (Figure 15). The specimens were subject to a stress ratio of  $R=0.1$  with a maximum cyclic load of 425 lbs at a maximum cyclic rate of 90Hz. All specimens were subject to constant amplitude cyclic loading and constant stress ranges. Specimens were initially pre-cracked at an approximate cyclic stress intensity factor of  $\Delta K=3.81 \text{ ksi}\sqrt{\text{in}}$ . Once the pre-crack length was obtained the crack was propagated at an increasing crack growth rate to obtain data in the linear crack propagation region. Upon reaching the maximum desired crack length, the crack extension was artificially stopped and the specimens were statically loaded to failure. The average temperature and percent humidity during testing was 75 °F and 50% respectively. The specimens were sealed in plastic bags with dry air to minimize the effects of humidity on crack growth behavior and data acquisition readings. Visual measurements were taken upon pre-crack cycling and during crack propagation to measure and compare crack lengths with data acquisition values.

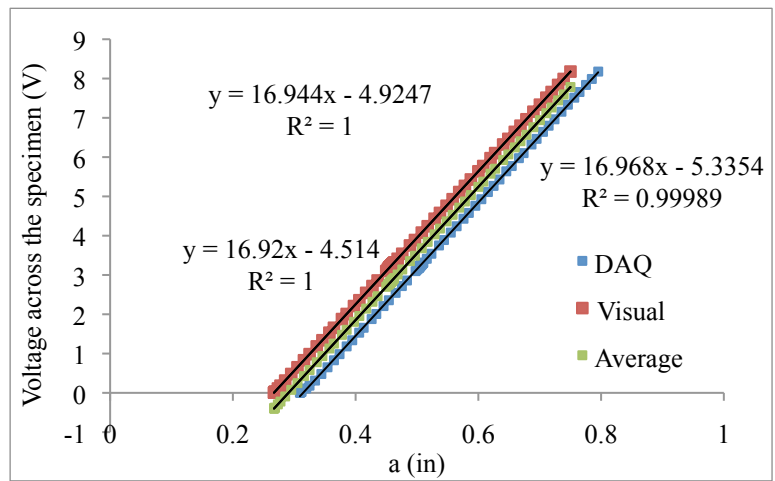
**Figure 17 Example of post processing DAQ and visual crack length values.** The crack length data were valid since there was a < 2% shift in the adjusted values

Visual measurements were used to post-process data acquisition values and generate a set of adjusted crack length values using a modified secant (MS) combo from the FCGR Analysis software (Figure 17). The crack growth rate analysis was performed with a 7 point-MS combo method that used a 7-point incremental polynomial technique, with a modified secant method to generate additional data that would result in a smoother crack growth curve.

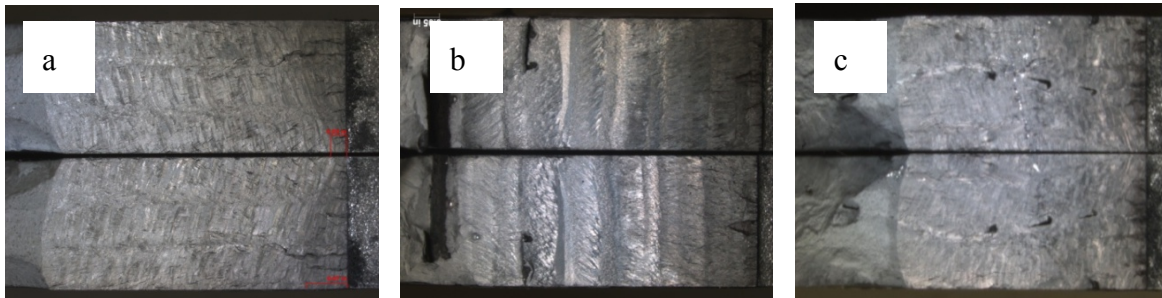
**Figure 18** The above images display both sides of fractured EBF3 2219 Al specimens and the direction of crack growth from the right (notch) side of the specimen to the left. a) T-L orientation displays smooth crack propagation along the direction of deposition. b) T-S orientation displays crack propagation behavior across the EBF3 layers. c) L-T orientation shows crack propagation across the bead passes

Upon post processing the fatigue crack growth data, adjusted crack length values and corresponding load cycles were generated from the cyclic testing. In an EBF3 specimen with an initial flaw subject to a specific load, it was important to determine the total number of cycles the material endured prior to unstable crack growth. Anisotropic fatigue life curves from the EBF3 2219 aluminum material were generated (Figure 19) and the corresponding fracture surfaces were examined and compared to the numerical analysis (Figure 18). The results showed different fatigue life behavior for each orientation. A specimen in the T-L orientation revealed that a crack propagating parallel to the direction of metal deposition required a cycle count of approximately 800,000 cycles to induce unstable crack growth. Specimens in the L-T and T-S orientations where crack propagated across the bead passes and perpendicular to the EBF3 layers showed faster crack growth. The average cycle counts required to generate unstable crack growth in the L-T and T-S orientations were 100,000 and 300,000 cycles respectively. An analysis on both sides of the fractured specimen for the different orientations revealed that cyclic crack growth behavior was also influenced by the microstructure of the 2219 EBF3 material. Non-uniform grain structure and the presence of anomalies and voids have possibly contributed to decreased fatigue life specifically in the T-S and L-T orientations (Figures 18b, 18c respectively). Conversely, the fracture surface for the specimen in the T-L orientation revealed smooth crack propagation along the direction of deposition (Figure 18a) that resulted in slower crack growth and an increase in fatigue life.

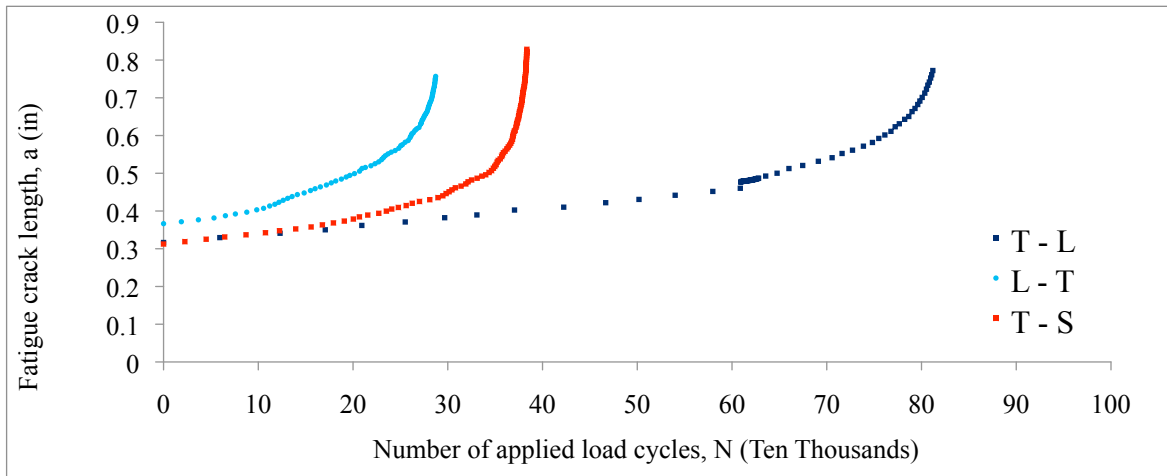
**Figure 19 Anisotropic fatigue life curves of 2219 EBF3 aluminum specimens under constant amplitude loading.**

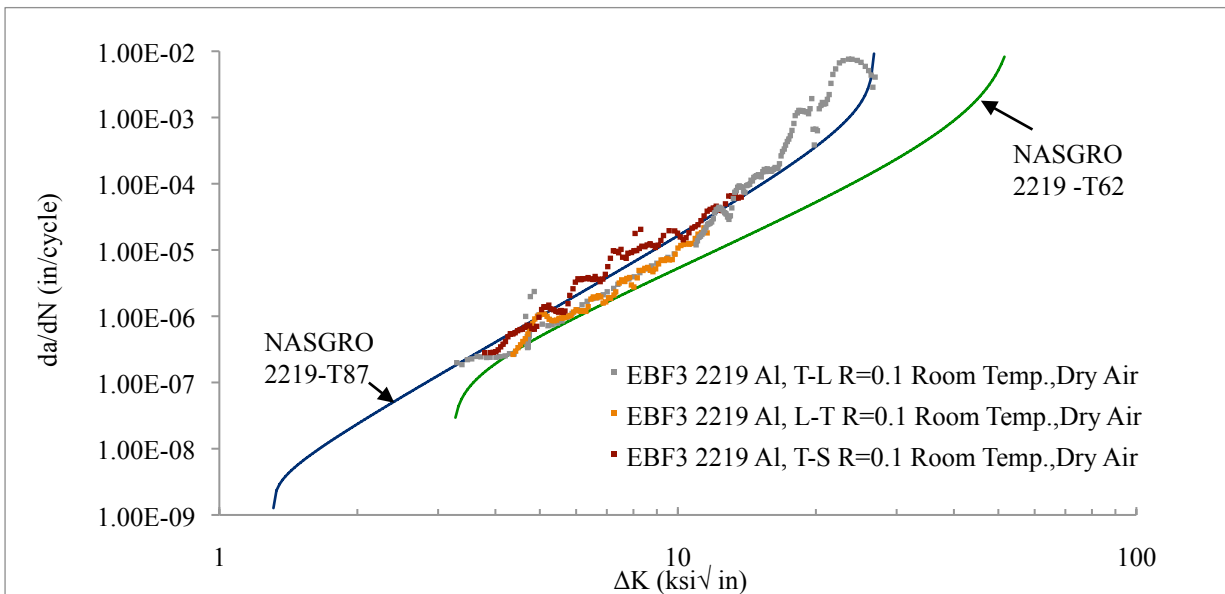
**Figure 20 Anisotropic fatigue crack growth data for EBF3 2219 aluminum in dry air  $R=0.1$ . The EBF3 material fails at a lower cyclic stress intensity factor than heat-treated aluminum;  $R=0.1$  Lab Air**

Fatigue crack growth data was further obtained to analyze the behavior of the specimens under cyclic loading once a flaw was initiated. The log of crack growth rate per cycle,  $\log(da/dN)$  was plotted over the log of the cyclic stress intensity factor range,  $\log(\Delta K)$ . Anisotropic fatigue crack growth data for different specimens were obtained and their crack growth data were analyzed over  $\Delta K$  (Figure 20). The fatigue crack growth data showed similar crack growth behavior for orientations T-L and L-T in the steady state regime. The specimens in the T-S orientation demonstrated faster crack growth in the linear region due to the non-uniform microstructure across the EBF3 layers. The 2219 EBF3 aluminum was compared to conventionally welded aluminum in the T87 condition and heat-treated aluminum in the T62 condition. The steady state and unstable fatigue crack growth results of EBF3 2219 aluminum were comparable to properties of welded 2219 aluminum in the T87 condition. Failure for material in the as deposited condition occurred at a low cyclic stress intensity factor of  $\Delta K=22\text{ksi}\sqrt{\text{in}}$ ; whereas the heat-treated 2219 aluminum failed at a higher stress intensity range of  $\Delta K=50\text{ksi}\sqrt{\text{in}}$ . The data also indicated that a crack in an EBF3 sample propagated at a faster rate and failed at a lower cyclic stress intensity range than heat-treated aluminum.

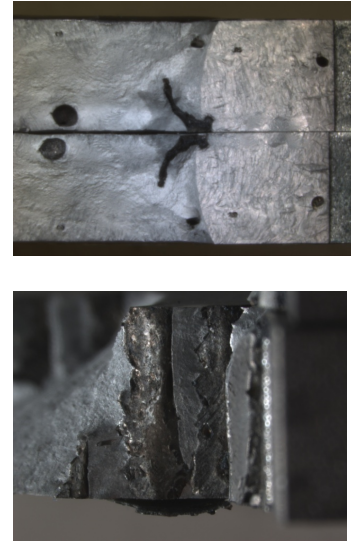
**Figure 21 Fracture surfaces of EBF3 2219 aluminum specimens demonstrated shear fracture upon failure**

The results showed that the EBF3 2219 aluminum fracture toughness values slightly varied with grain direction (Table 5). Cracks had also been propagated to different lengths prior to fracture and revealed no significant differences in toughness values. Specimens in the T-L orientation endured a maximum load of 2448 lbs. prior to failure (Figure 22) but had marginally lower toughness values than the T-S orientation. The anisotropic results of the EBF2 2219 aluminum showed no significant difference in fracture toughness values obtained from different orientations. The properties of conventionally welded aluminum revealed that the fracture toughness of EBF3 2219 aluminum had decreased by 30% and was 3 times less than heat-treated 2219 aluminum in the T62 condition. Earlier tensile data revealed that low ductility in EBF3 2219 aluminum had contributed to low toughness values.

The toughness data revealed that the EBF3 2219 material fractured above yield strength and abided by the linear elastic fracture mechanics criteria. All fractured fatigue crack growth specimens demonstrated ductile fracture along 45° planes through the specimen thickness. The fractured surfaces displayed single shear mode fracture due to an increase in plastic zone near the specimen crack tip as the crack propagated and developed plane stress<sup>8</sup>. This was expected since the crack tip deformation in thin specimens, occupy a large percentage of the specimen thickness, and the stresses were likely to behave in plane-stress rather than plane-strain.

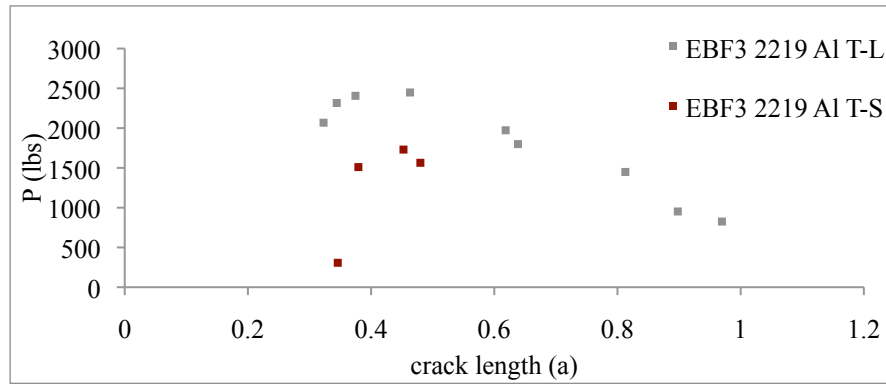
**Figure 22 R-curve for 2219 aluminum in the as deposited condition.**
